Title: Special Analysis: 2016-002, Analysis of Cover Erosion and Enhanced Infiltration at Pit 25, TA-54 Area G

Special Analysis: 2016-002
Analysis of Cover Erosion and Enhanced Infiltration at Pit 25,
TA-54 Area G

UDQE Reference Number:
UDQE-1602

Authors:
Kay Birdsell, Zhenxue Dai, Philip H Stauffer, and Sean B. French
Los Alamos National Laboratory

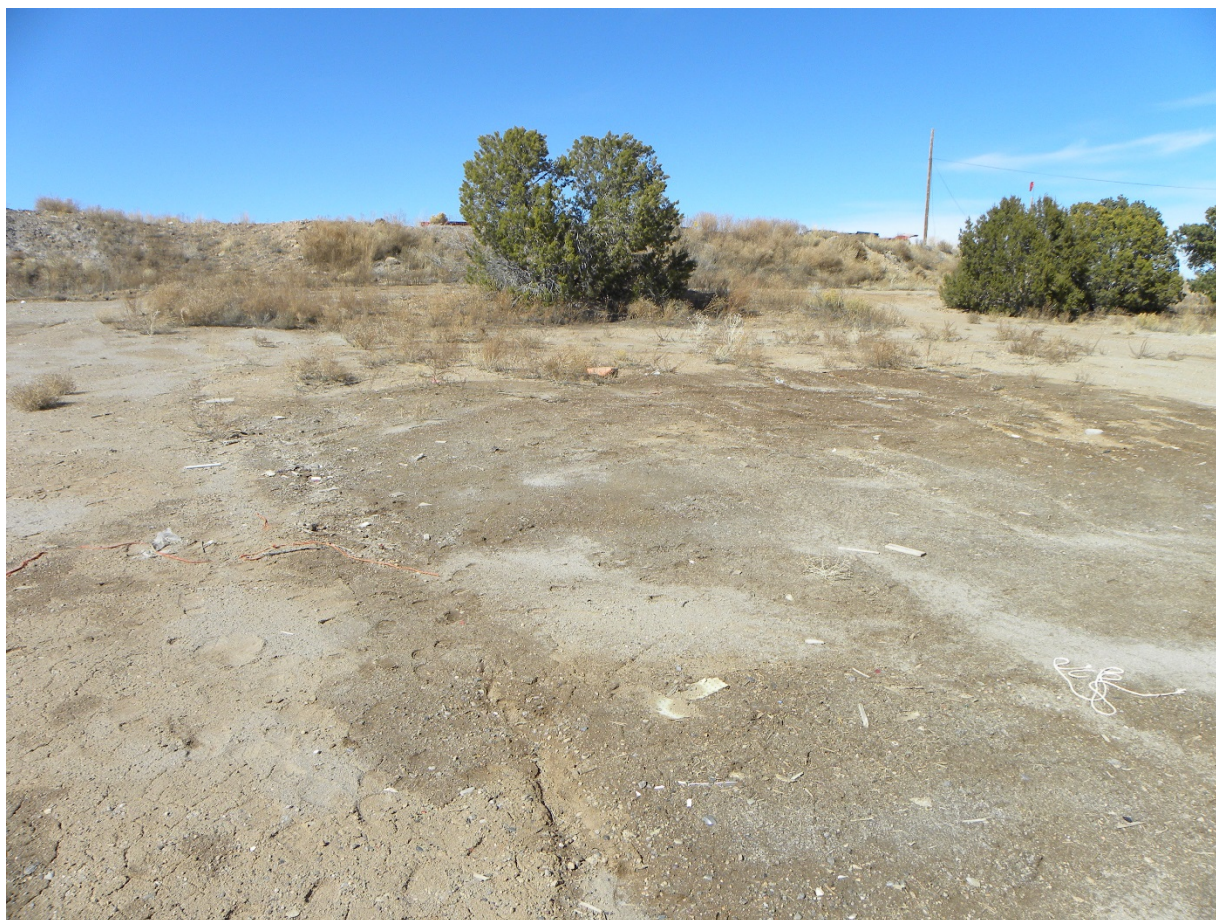
Notable erosion was observed in the operational cover at Pit 25 at Area G in March 2105 during a site walkdown following clean-up of excess material (e.g., rows of large metal containers, and piles of pallets and scrap metal) at a surface disposal site known as the “boneyard.” The field team observed evidence of run-on, erosion, and ponding over Pit 25 and part of Pit 26. In addition, they noticed possible vertical metal panels of unknown origin within the Pit 25 cover. Figures 2-1 and 2-2 show two photographs documenting the field observations on March 5, 2015.

Figure 2-1. Photograph showing signs of erosion and wet surface conditions at Pit 25, March 5, 2015.

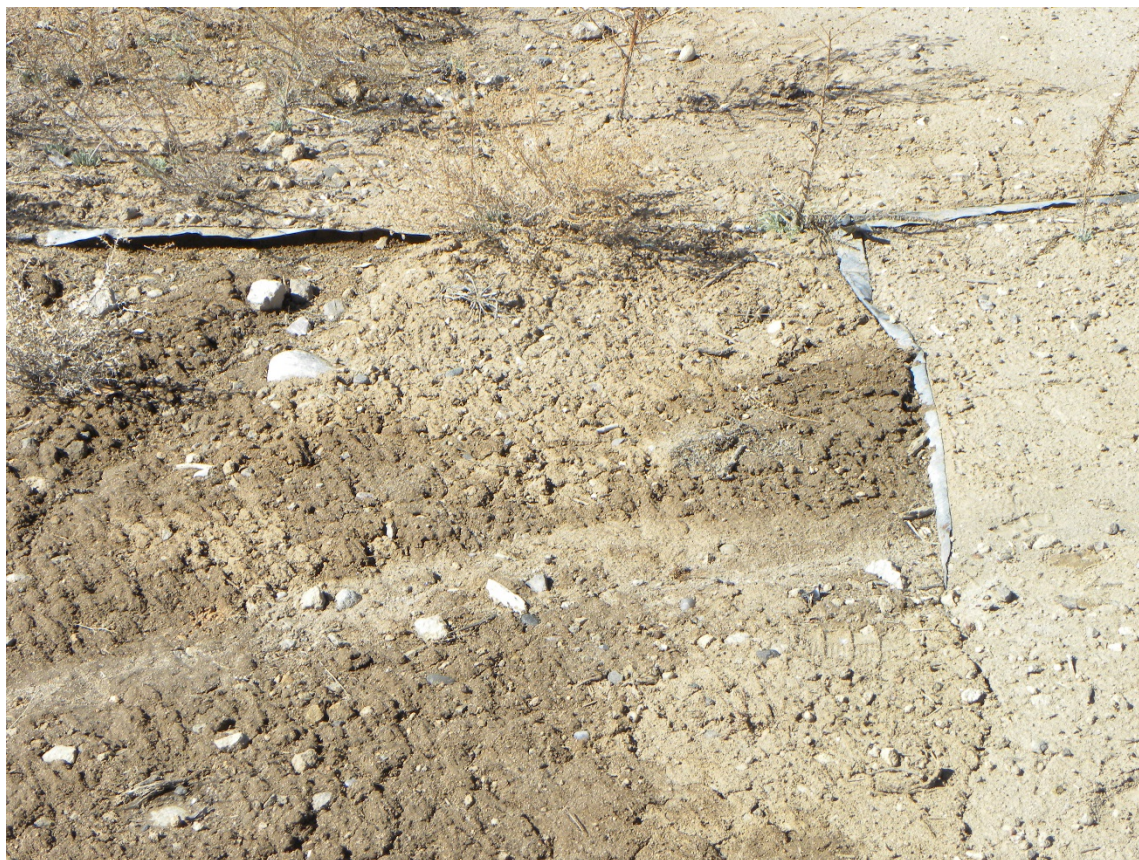
Figure 2-2. Photograph showing possible vertical metal panels in Pit 25 operational cover, and signs of erosion and wet surface conditions, March 5, 2015.

Pit 25 has an operational cover. It was determined that the linear metal strips observed in the Pit 25 cover (Figure 2-2) are most likely associated with four unconventional bio-intrusion-barrier test plots that were constructed over a portion of the pit (Nyhan et al., 1986; Nyhan, 1989) when Pit 25 was closed in late 1981. The test plots were placed on top of the waste and backfill to monitor the performance of pit cap designs with respect to plant root intrusion and uptake, and percolation of water into the pit backfill (Figure 2-3). Each of the four plots has a size of 6 m x 12 m and a thickness of 1 m. They are covered with 15 cm of topsoil. Plot 1 to Plot 4 consists of 15 cm gravel and 85 cm of cobble; 100 cm of cobble; 100 cm of crushed tuff; and 30 cm gravel and 70 cm cobble, respectively (Figure 2-4). The test plots cover 8.0% of Pit 25, based on its size [120 m x 3 m, (Table 1 of French and Shuman, 2014)].

- Survey the x, y, z coordinates of the metal panels discovered in the Pit 25 cover. At the same time, and where possible, survey apparent pit edges/corners with x, y, and z coordinates for pits 25 & 26. The deliverable for this effort should be raw data and maps/drawings showing survey points.

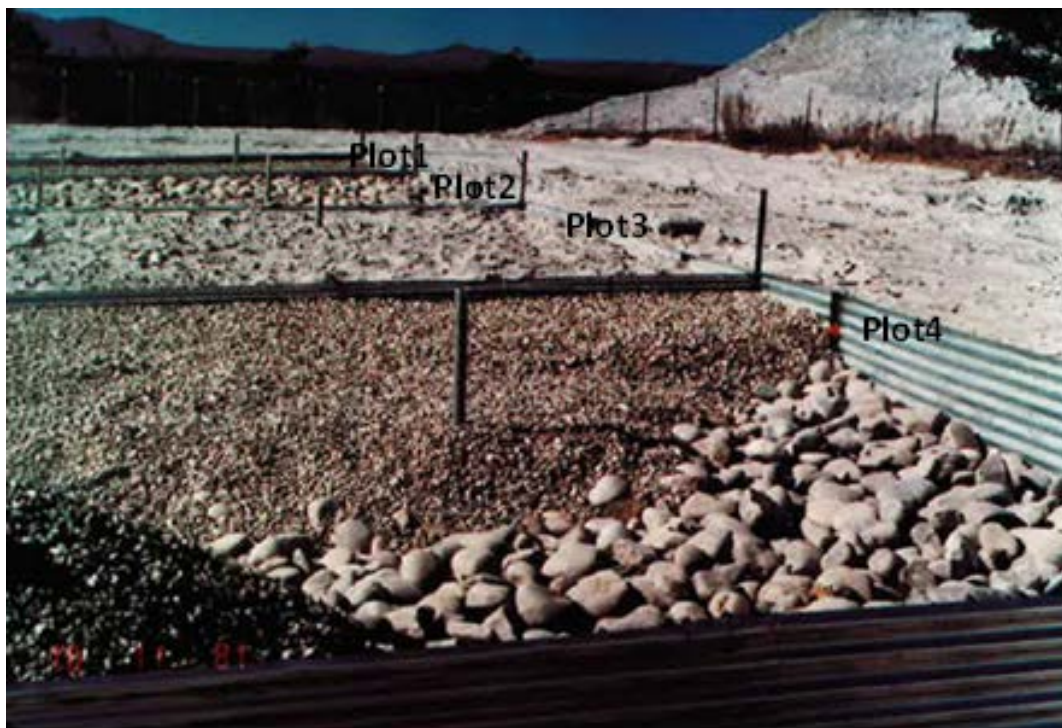
Figure 2-3: Four bio-intrusion-barrier plots constructed on part of Pit 25 in 1981. Portions of the barrier materials are shown here during construction, before the final 15cm of topsoil was added on each plot.

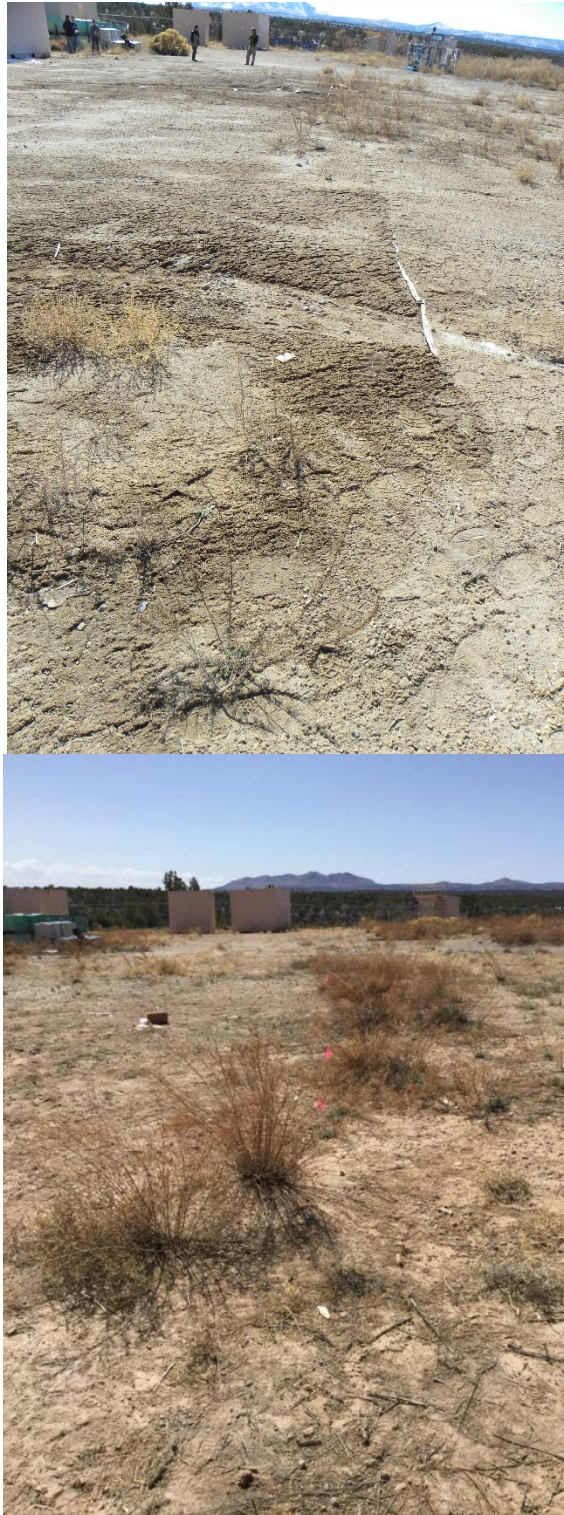
Figures 3-1 through 3-5 show the photographic comparisons between conditions in March 2015 to those from November 2017 or April 2018. The March 2015 photographs were taken relatively soon after site cleanup (Section 2) was conducted when little vegetation was present. Observations noted from this comparison of photos show the following changes in the roughly 2.5 to 3 years since the original photographs were taken.

Figure 3-1. Pit 25 looking west, (top) photo from March 5, 2015, showing erosion rills and east-west running metal strip at northern edge of test plots; (bottom) photo from April 3, 2018, showing fewer rills, additional vegetation, and flags marking location of metal strip at northern edge of test plots.

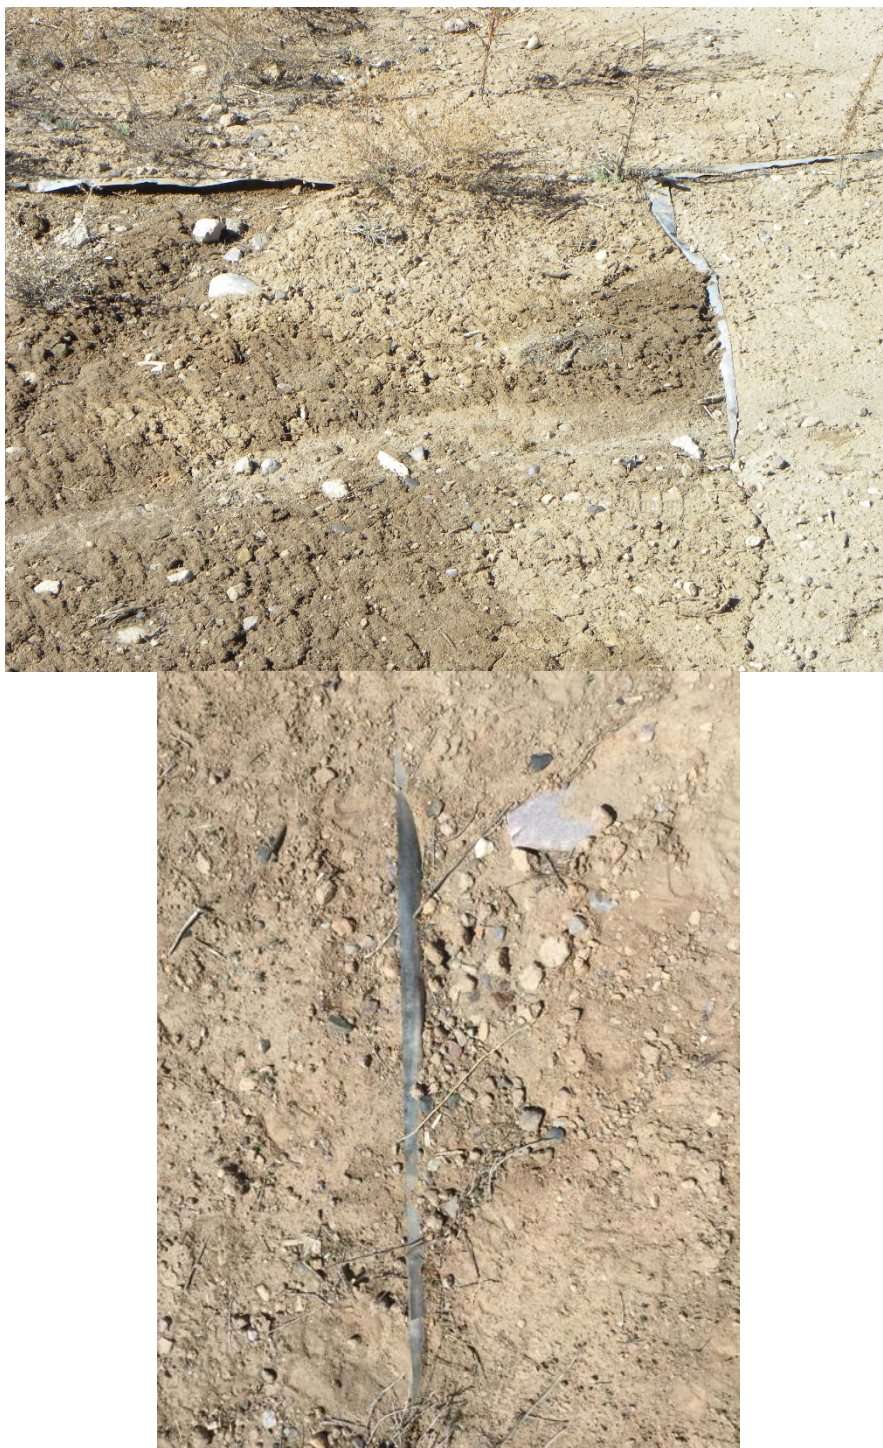
Figure 3-2. Pit 25 looking north, (top) photo from March 5, 2015, showing erosion rills and junction of metal strips that bound the test plots; (bottom) photo from April 3, 2018, showing north-south running metal strip near northern edge of test plots; junction shown in top figure is covered. Both photos show cobbles from the test plots.

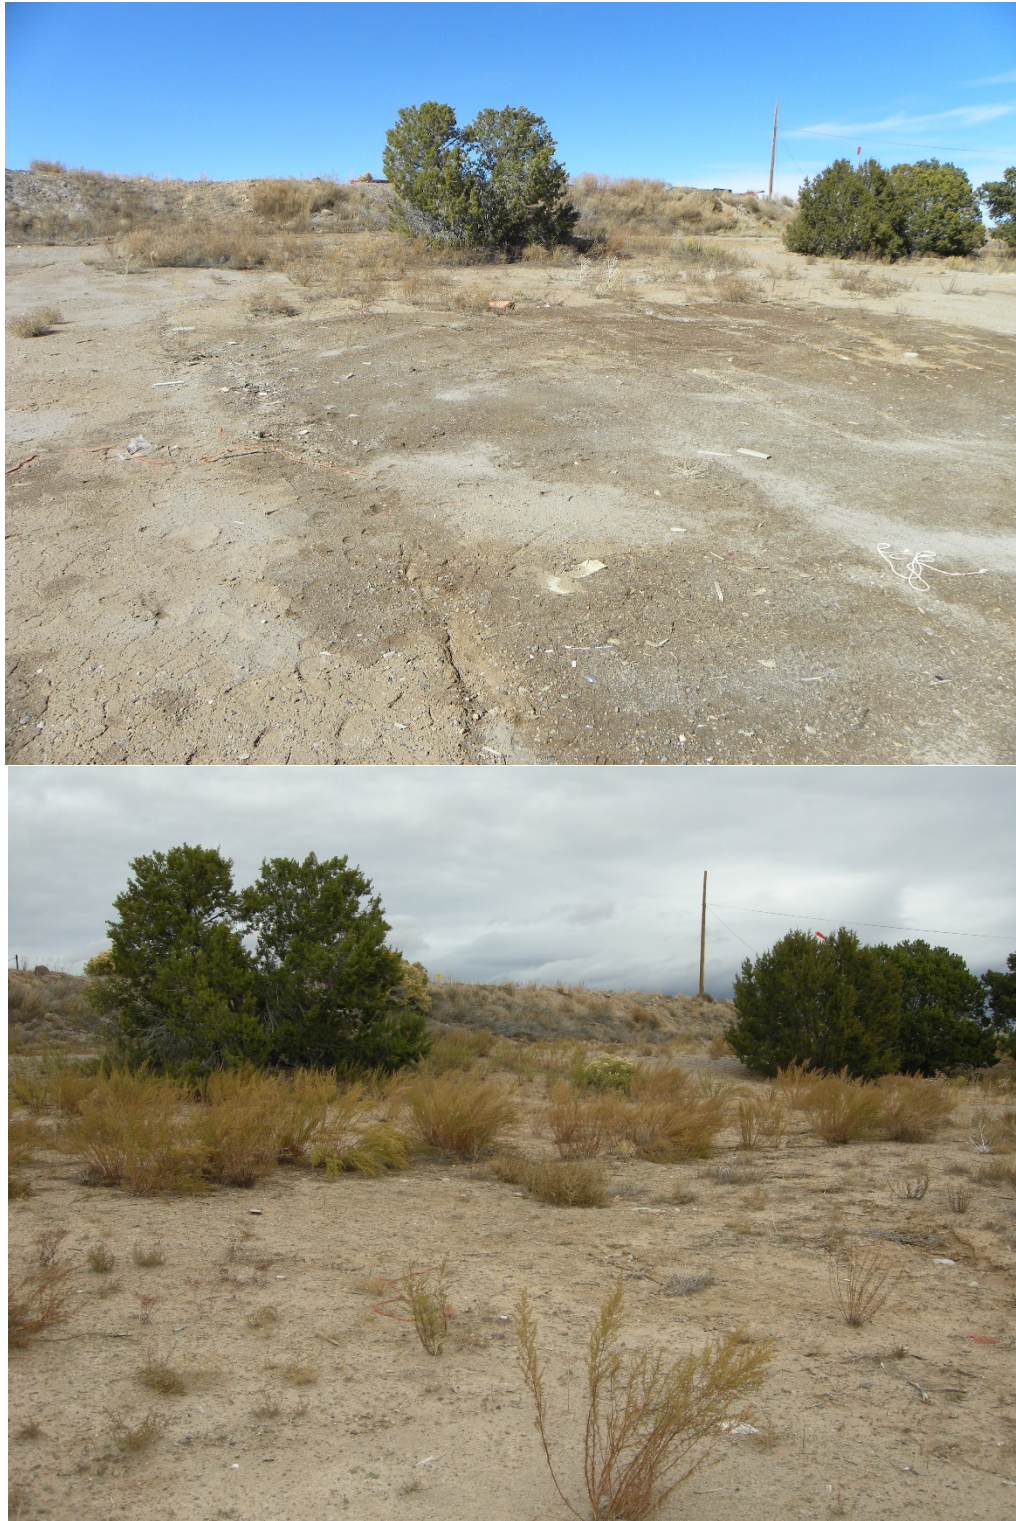
Figure 3-3. Pit 25 looking north-northeast, (top) photo from March 5, 2015, showing erosion rills and wet surface conditions; (bottom) photo from November 7, 2017, showing fewer rills, additional vegetation and soil, and drier conditions.

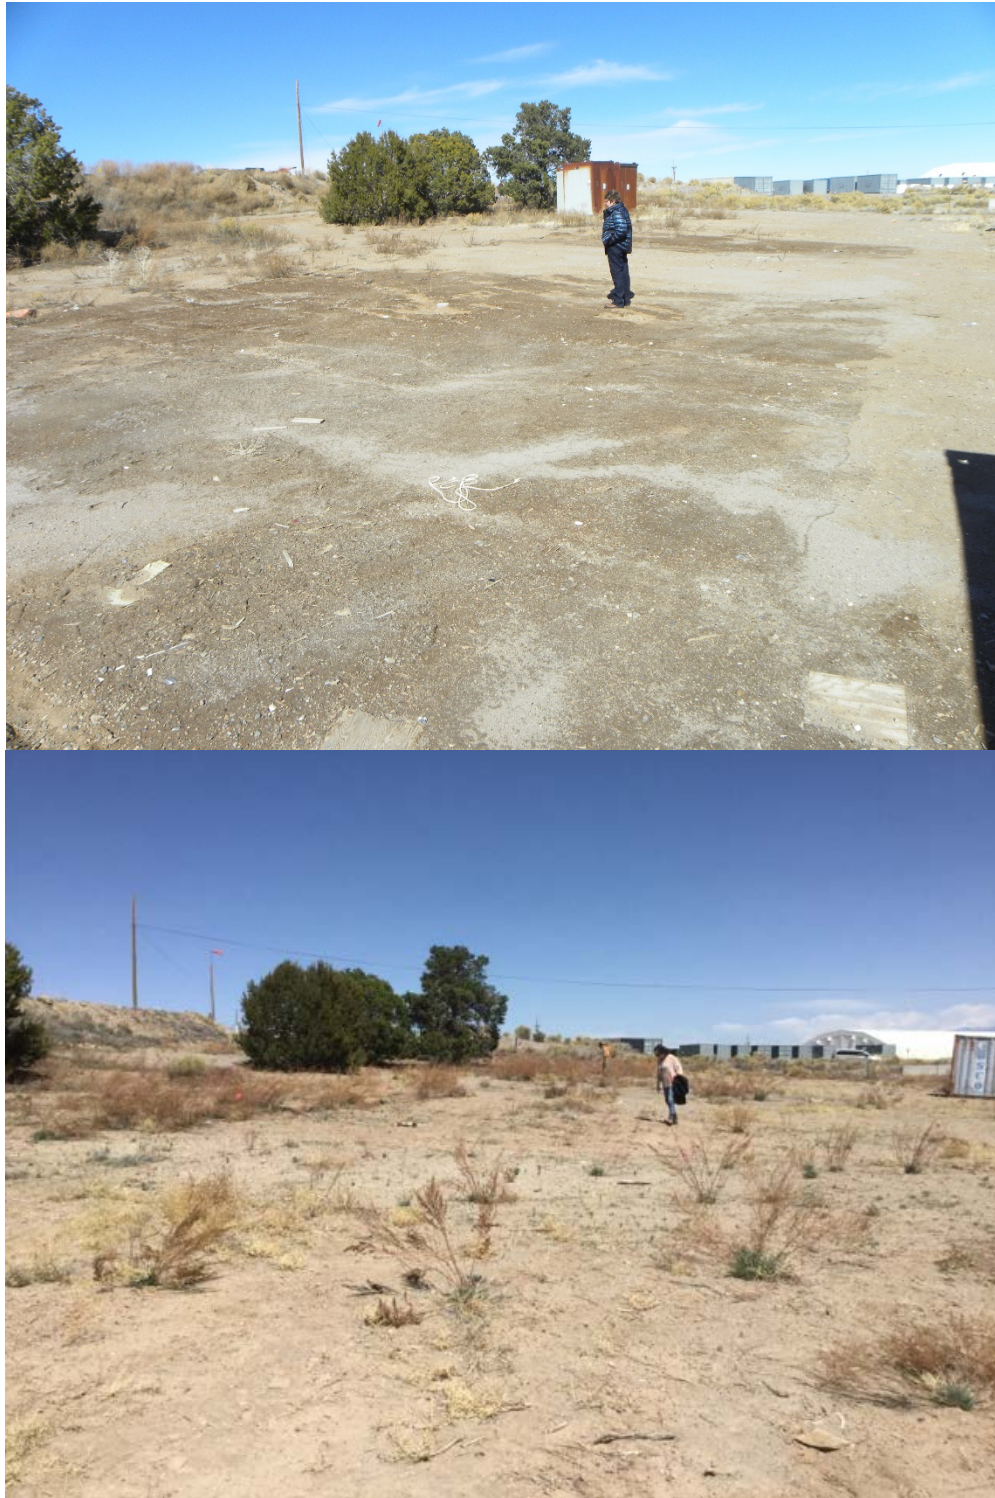
Figure 3-4. Pit 25 looking east-northeast, (top) photo from March 5, 2015, showing erosion rills and wet surface conditions; (bottom) photo from April 3, 2018, showing fewer rills, additional vegetation, and a flag marking the northern edge of the test plots.

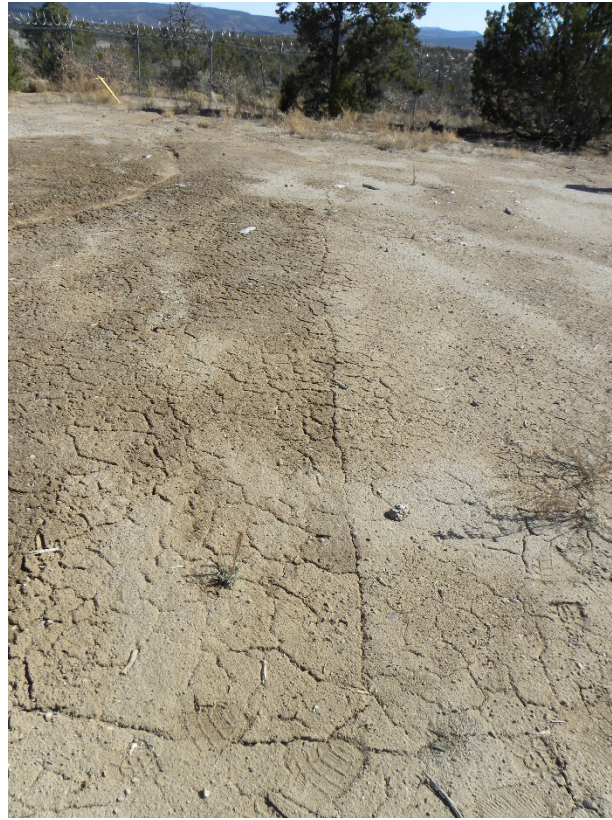
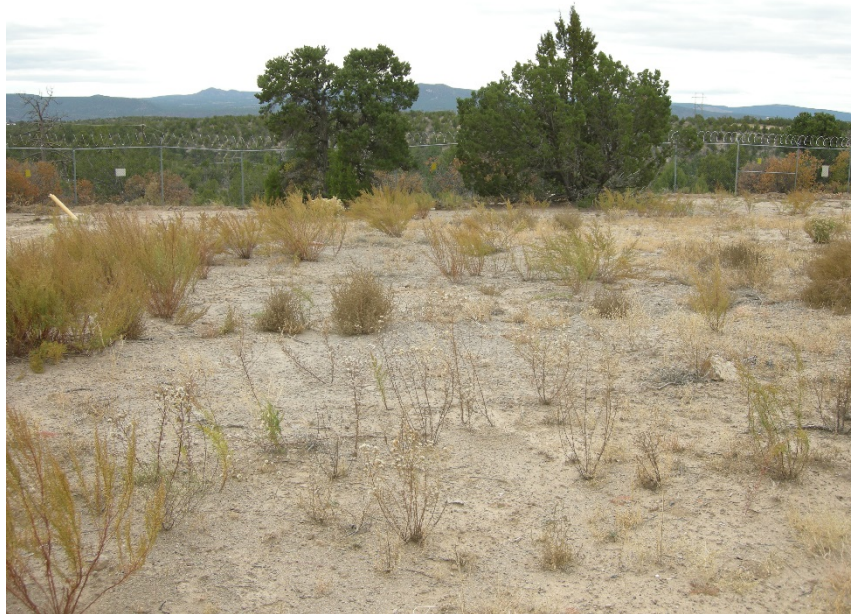
Figure 3-5. Pit 25 looking south, (top) photo from March 5, 2015, showing erosion rills, surface cracking, and wet surface conditions; (bottom) photo from November 7, 2017, showing fewer rills, and additional vegetation and presence of new soil.

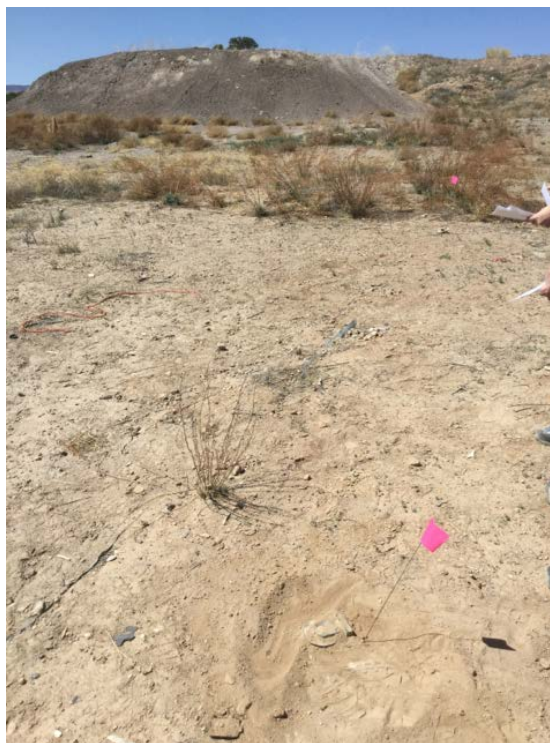
Figure 3-6. Pit 25 looking north, photo from April 3, 2018, showing north-south running metal strip; approximate location of junction with east-west running metal strip is marked with a flag near the top of the photo. The flag in the lower portion of the photo is likely a neutron access hole installed into the test cover.

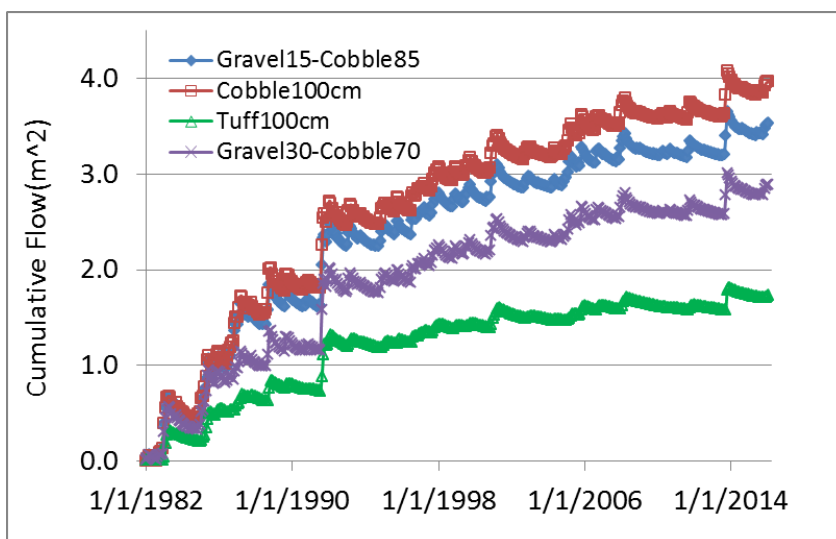
The cumulative flow rates across the base of the four test plots in shown in Figure 3-7. Cumulative flow across the base of the crushed tuff test plot is much less than those of the other three test plots, which have less water retention capacity. These results indicate that cumulative flows through Plots 1, 2, and 4, which are constructed primarily of cobble, are 1.7 to 2.3 times the volume of water that has percolated into the waste through Plot 3, which is constructed of crushed tuff. Therefore, enhanced infiltration is occurring through three of the four test plots in comparison to a conventional operational cover constructed of crushed tuff. This condition of enhanced infiltration is inconsistent with assumptions related to groundwater flow used in the PA/CA.

Figure 3-7: Computed cumulative water flow rates (m^2) across the bottoms of the four test plots

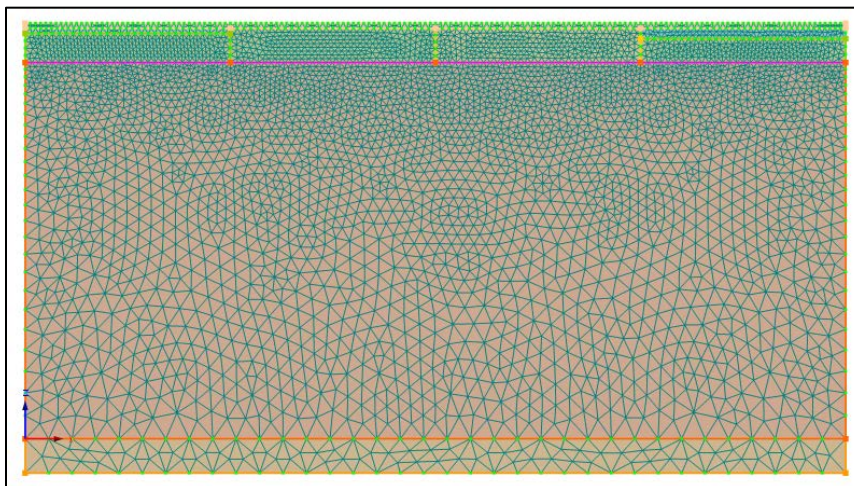
Figure B-2: Numerical grid of the two-dimensional Hydrus model for Pit 25

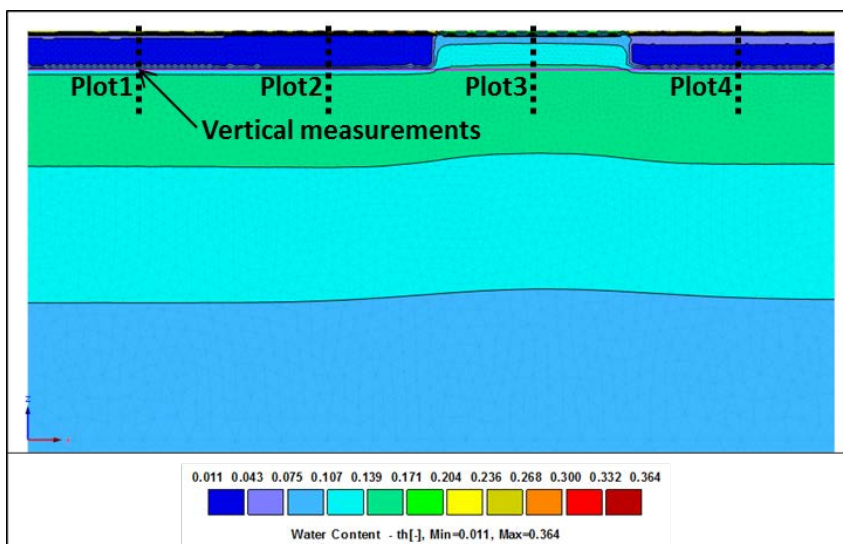
Figure B-3: Simulated water contents at the end of April, 1985 for Pit 25 with the four bio-intrusion barriers

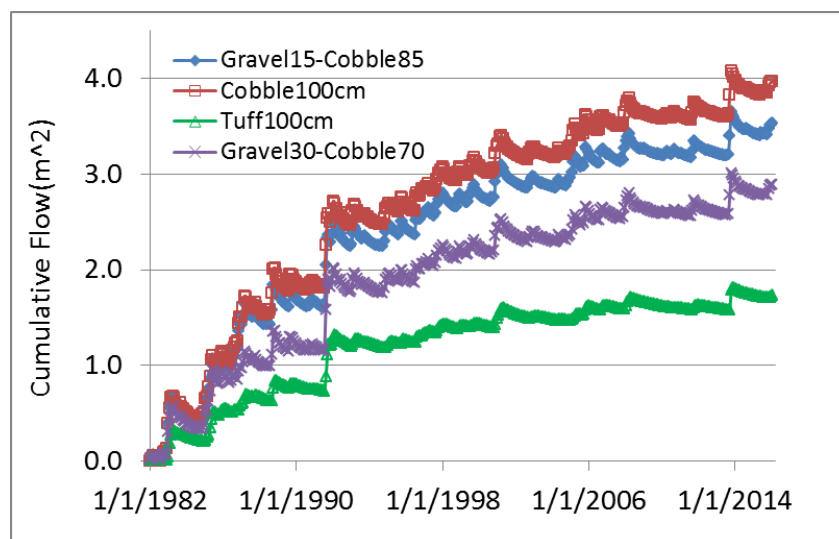
The cumulative flow rate across the bottom of the crushed tuff plot is much less than those of the other three test plots (Figure B-7), which have less water retention capacity because of the large percentage of cobble (70-100%) present in the cover. These results indicate that over twice (2.3

time) the volume of water has percolated into the waste through Plot 2, which is constructed of cobbles, than through Plot 3, which is constructed of crushed tuff. Cumulative flows through Plot 1 (2.0 times) and Plot 4 (1.7 times) are also significantly higher than through Plot 3. Therefore, enhanced infiltration occurs through the test plots in comparison to a conventional operational cover constructed of crushed tuff.

Figure B-7: Computed cumulative water flow rates (m²) across the bottoms of the four plots
